FIRST CHOICE INSPECTIONS

Building & Timber Pest Report

Inspection Date: 19 Oct 2023

Property Address: 4 Chevrotain Place Chermside West 4032

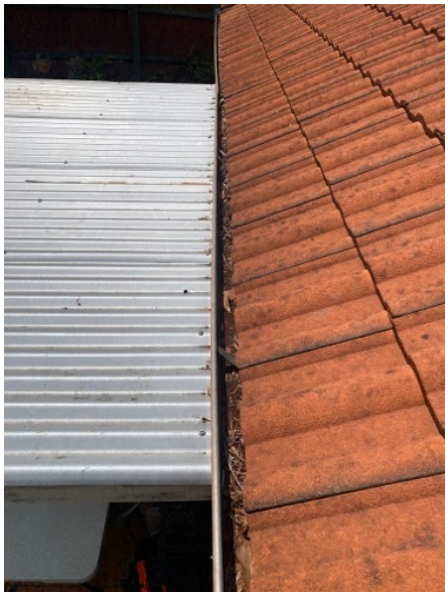
Minor Defect 1.02

Location: Roof exterior

Finding: Gutters - blocked

Blocked gutters are likely to lead to high levels of moisture in the affected areas. Such moisture will not only cause rust and decay of the associated building materials, but can also provide conditions that are conducive to termite and timber pest activity. Blockages in gutters should therefore be removed immediately to ensure dry conditions are maintained.

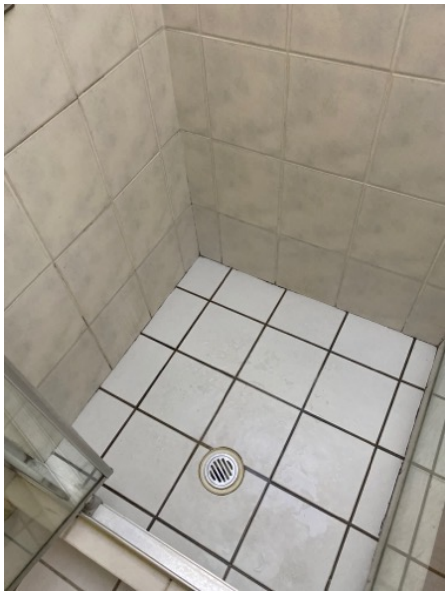
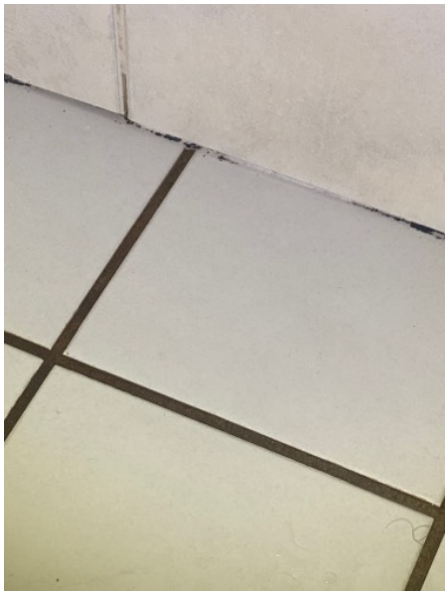
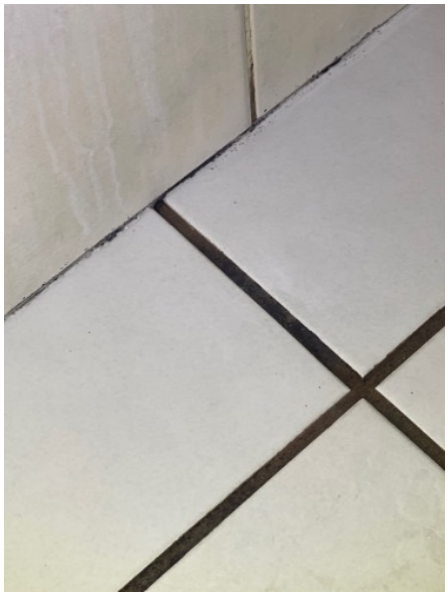
Minor Defect 1.03

Finding: Deterioration to grout and silicon

Deterioration was found to the grout and silicon in the shower area. It is recommended the grout and silicon be replaced to the tiled areas to reduce the risk of water penetration through these areas.

It is recommended a shower restoration company or licensed tiler be engaged to carry out this work.

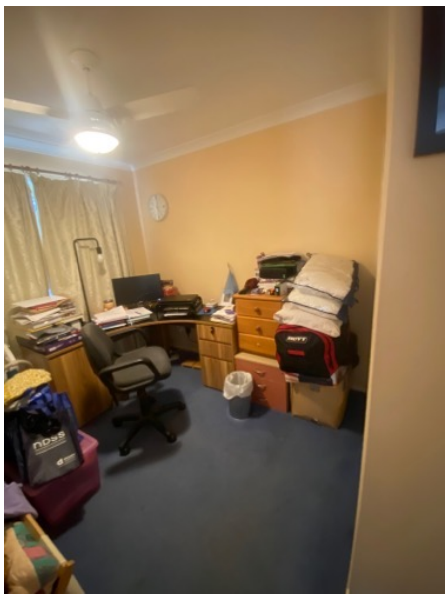
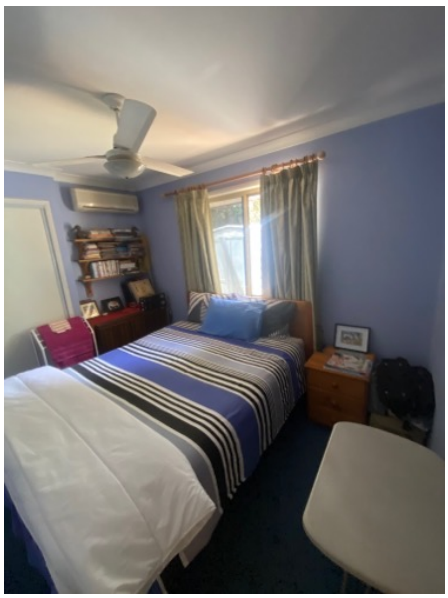
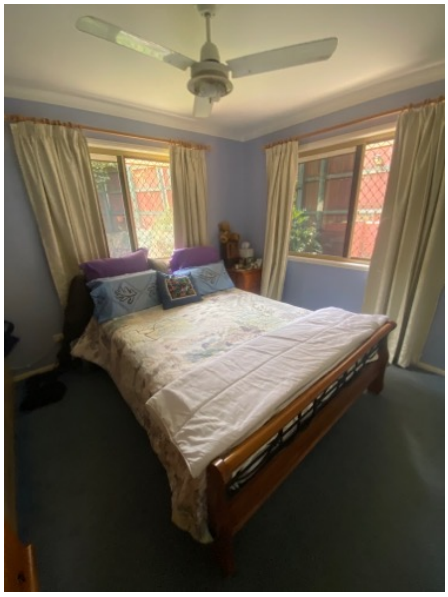
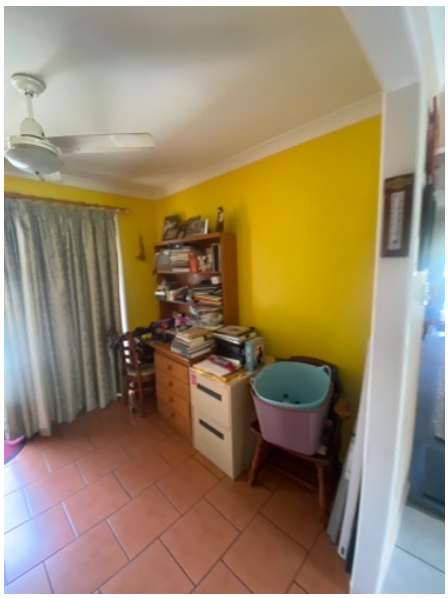
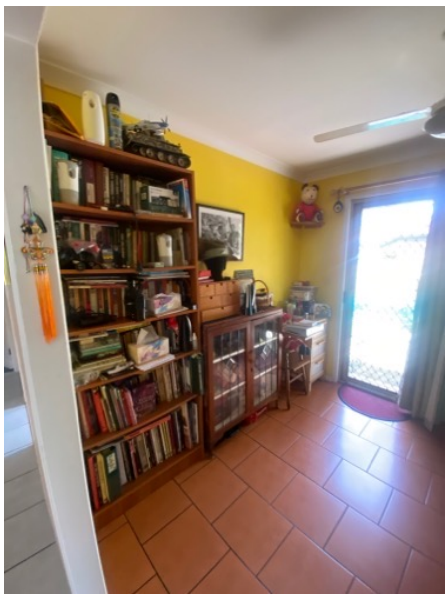
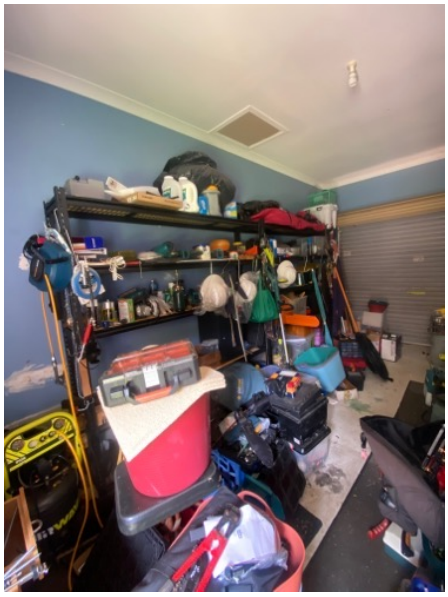
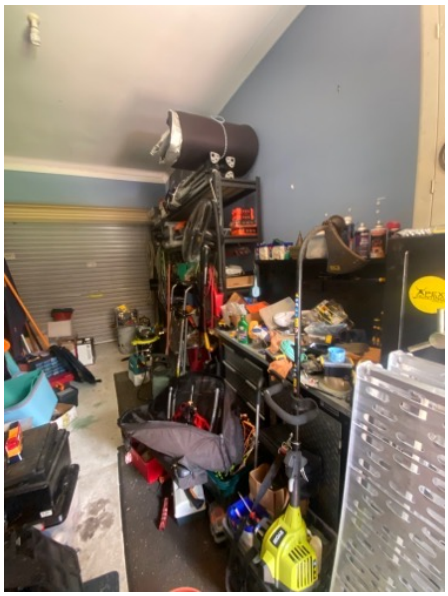
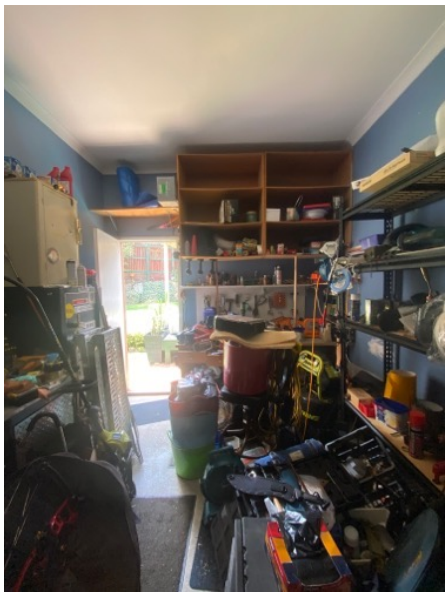
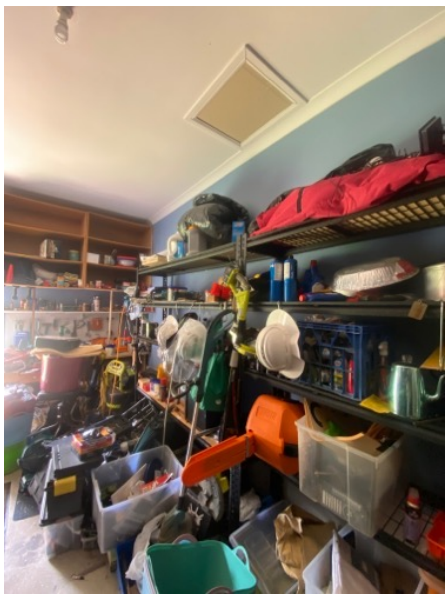
Finding: Obstructions and limitations

These photographs are an indication of the obstructions and limitations which impeded full inspection of the property at the time of inspection. These items were unable to be removed or disturbed during the inspection. Where items cannot be removed the level of risk for undetected defects increases.

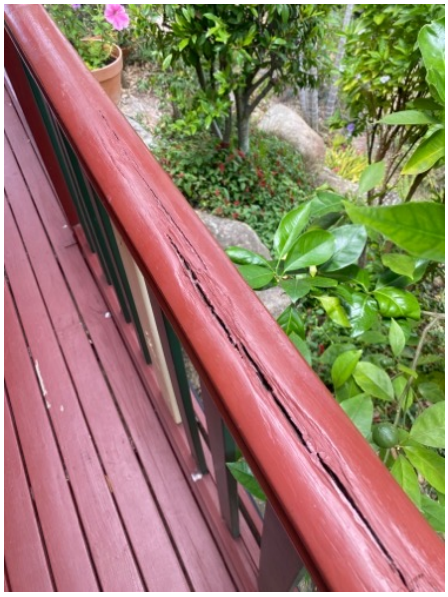
Timber pest attack 3.02

Location: Front Deck

Finding: Wood rot to front handrails

Wood rot has developed in the timber handrails on the front deck. Wood rot occurs to timber when is it is exposed to moisture on a regular basis.

It is recommended a carpenter is engaged to replace the handrails where required.

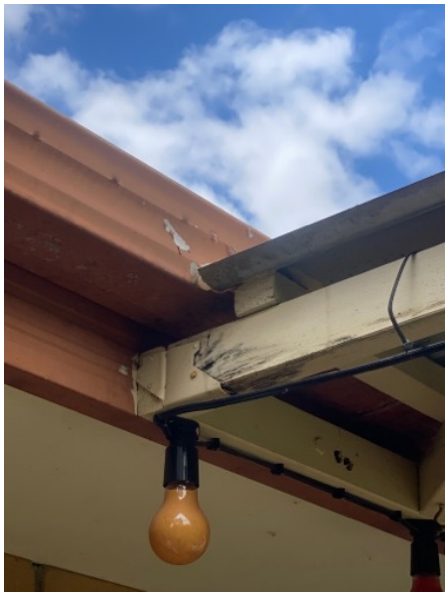
Location: Side Patio

Finding: Wood rot to patio timbers

A small patio has been constructed on the side of the property. The timber used in the structure does not appear to of been an external grade timber suitable for this external application and has developed wood rot in a number of areas that will affect the structual integrity of the timber. It is recommended the structure be removed.

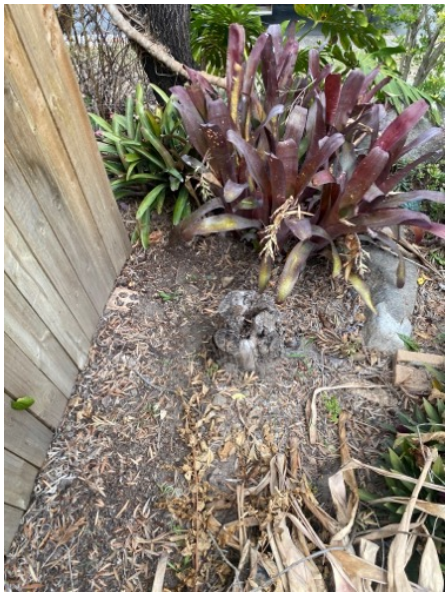
Conditions conducive to timber pest attack 3.05

Location: The Yard

Tree stumps were found in the yard. Tree stumps are an ideal habitat for termites and make ideal nesting locations. It is recommended they be removed by stump grinding or excavation. Where tree stumps cannot be removed they should be monitored on a regular basis (monthly) by a licensed pest inspector for signs of termite infestation and activity.

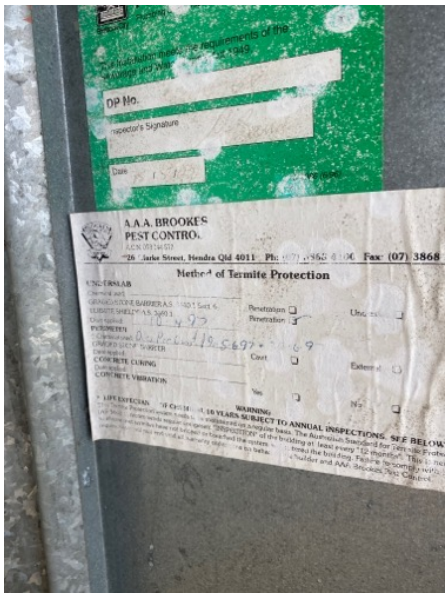
For your information 3.07

Location: All External Areas

Evidence of a previous chemical treatment termite management system was found. The durable notice indicated the system has since passed its effective lifespan and should be replenished.
